Test Report

Report No. A2180226390101001

Sample Name Weight Indicator
Type K9
Material 塑料 PC+PBT
Sample Receiving State Normal
Sample Received Date Nov. 20, 2018
Testing Period Nov. 20, 2018-Dec. 27, 2018

Test Item: IP6X

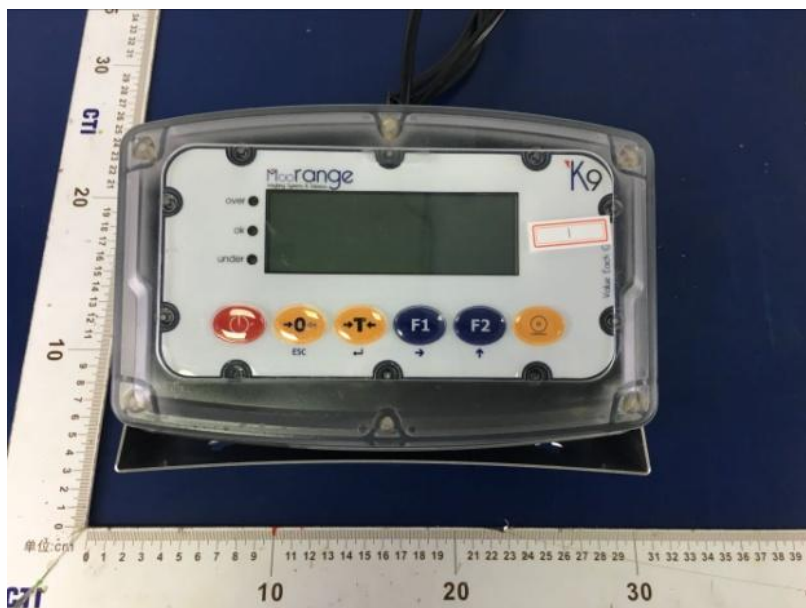
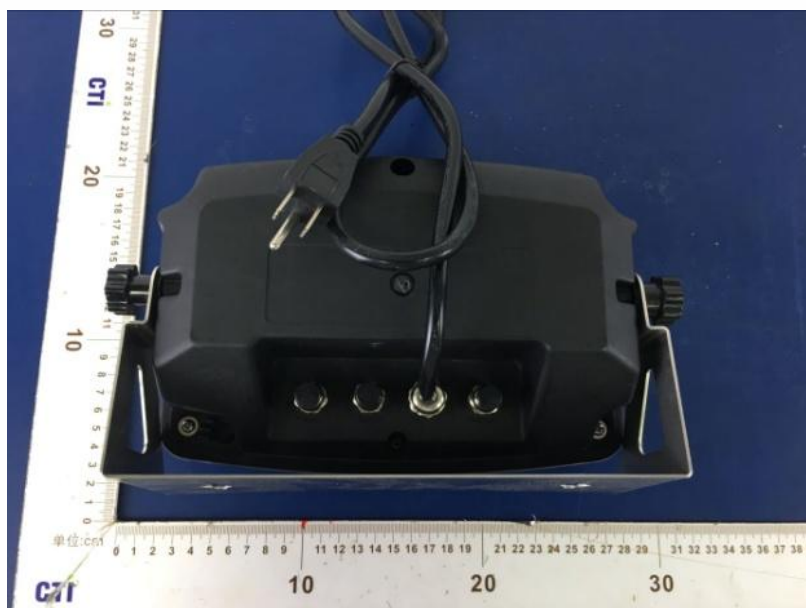
A2180226390101001

Sample Photo(s)

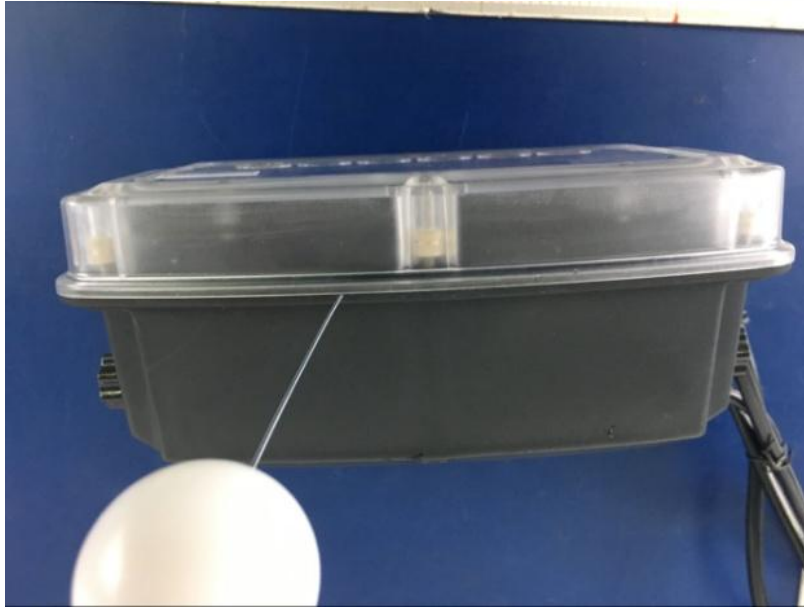
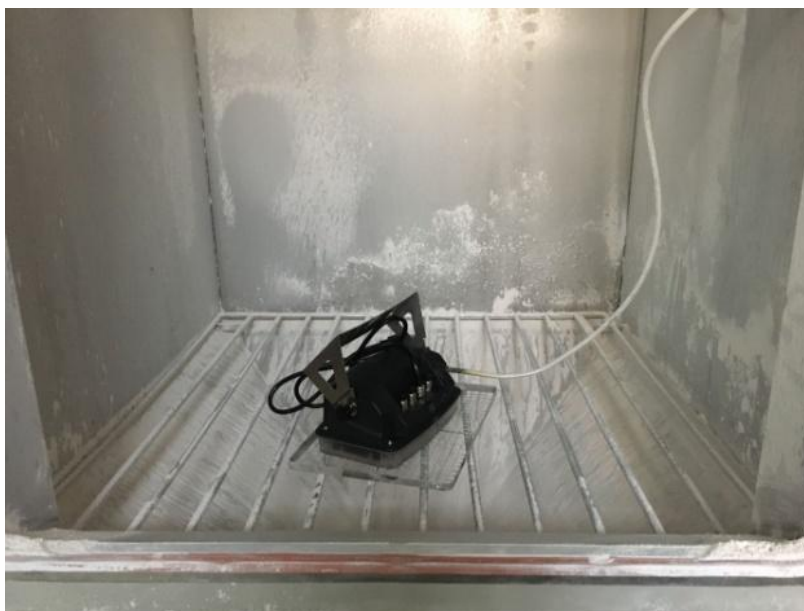
- a) Test prober of 1mm diameter is pushed against any opening of sample with force of 1 N;
- b) Set the sample in the dust chamber, the pressure inside the enclosure is maintained below the surrounding atmospheric pressure by a vacuum pump (40~60 times of the shell volume per hour; differential pressure between the containment and atmosphere: $\leq 2\text{kPa}$);
- c) The talcum powder to be used is 2kg/m^3 of the test chamber volume
- d) Test duration: 2 hours

Test set-up photos

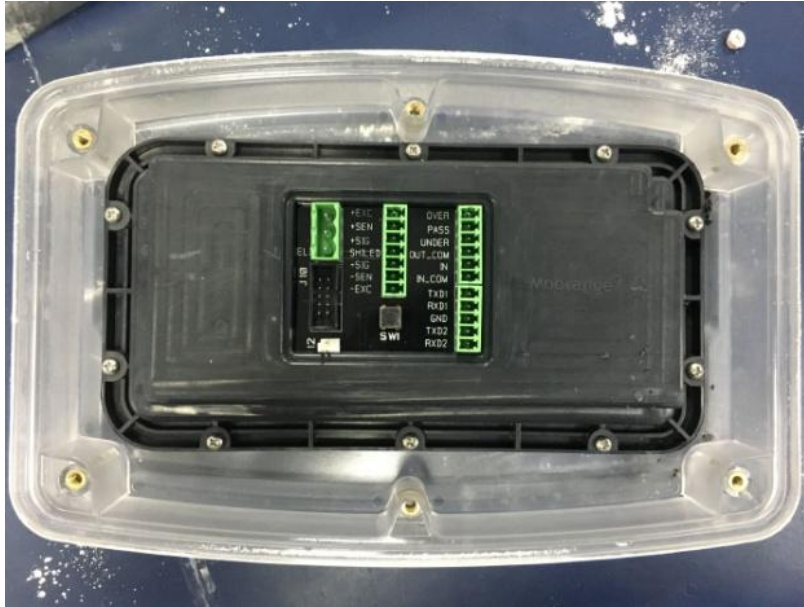
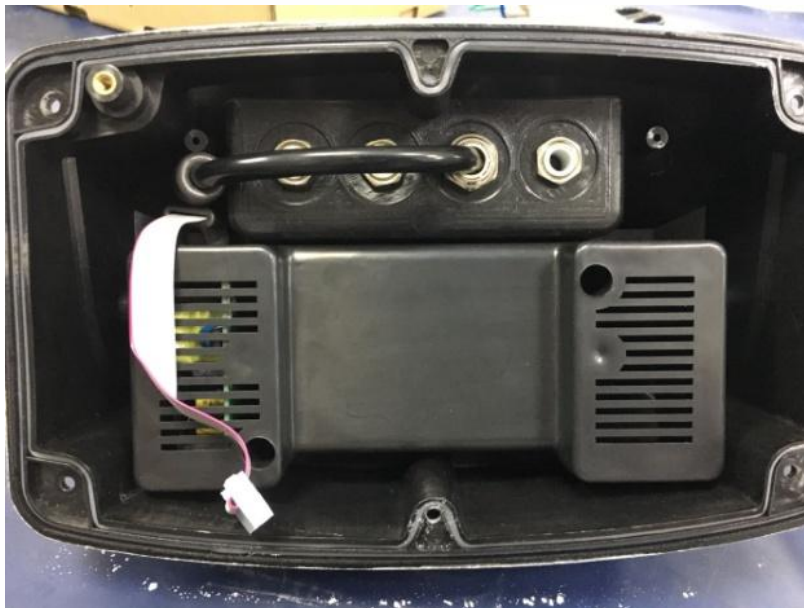
Sample No.	Test Result(s)
A2180226390101001	Visual inspection, test probe cannot into the sample. No obvious dust was observed in the sample after test. IP6X test was passed.

Sample Photo(s) after the test
