Report No. A2180226390101003 Page 1 of 7

Sample Name Weight Indicator

Test Item: IPX9K

3. Test Standard: As requested by client and refer to ISO 20653:2013

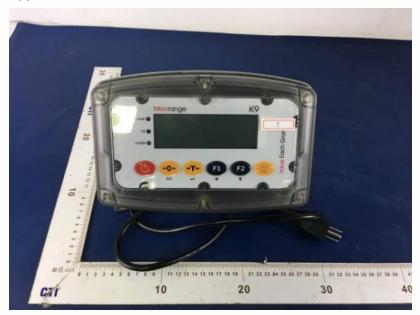
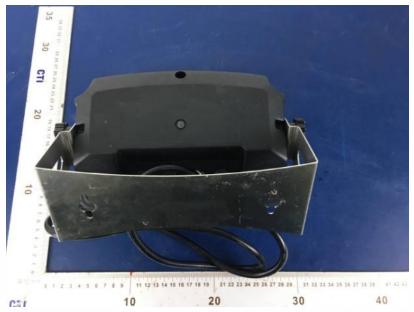
A2180226390101003

Sample Photo(s)

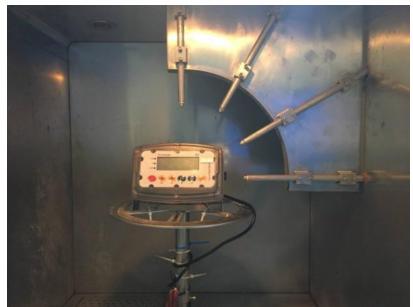
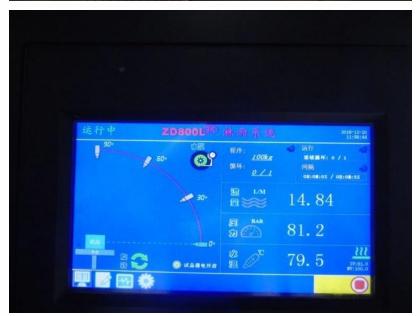
Test Photo(s)

Test set-up photos

-a) The rotation speed of the turntable: (5 ± 1) r/min

-b) Water flow rate: 14~16 L/min

-c) Hydraulic pressure: 8000~10000 kPa

-d) Water temperature: (80 \pm 5) °C

-e) Nozzle: flat-fan nozzle 0 °, 30 °, 60 °, 90 °

-f) Distance from sample surface to nozzle: 100~150 mm

-g) Test duration: 30 s per position

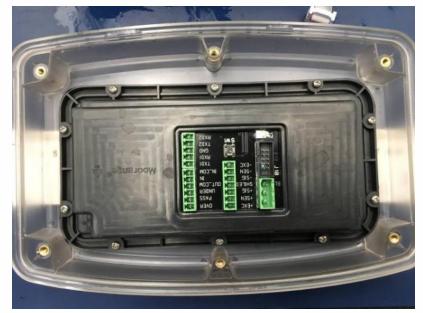
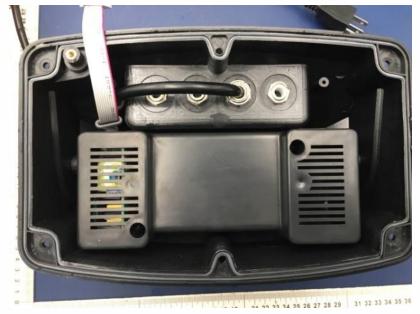
Sample Photo(s) after the test

| Sample No. | Test Result(s) | |
|---|--|--|
| A2180226390101003 | No water was observed in the sample by visual inspection after test. | |
| | IPX9K test was passed. | |
